Minnesota Department of Natural Resources  
Division of Fish and Wildlife  
Section of Fisheries

Stream Survey Report

Seven Mile Creek 2019

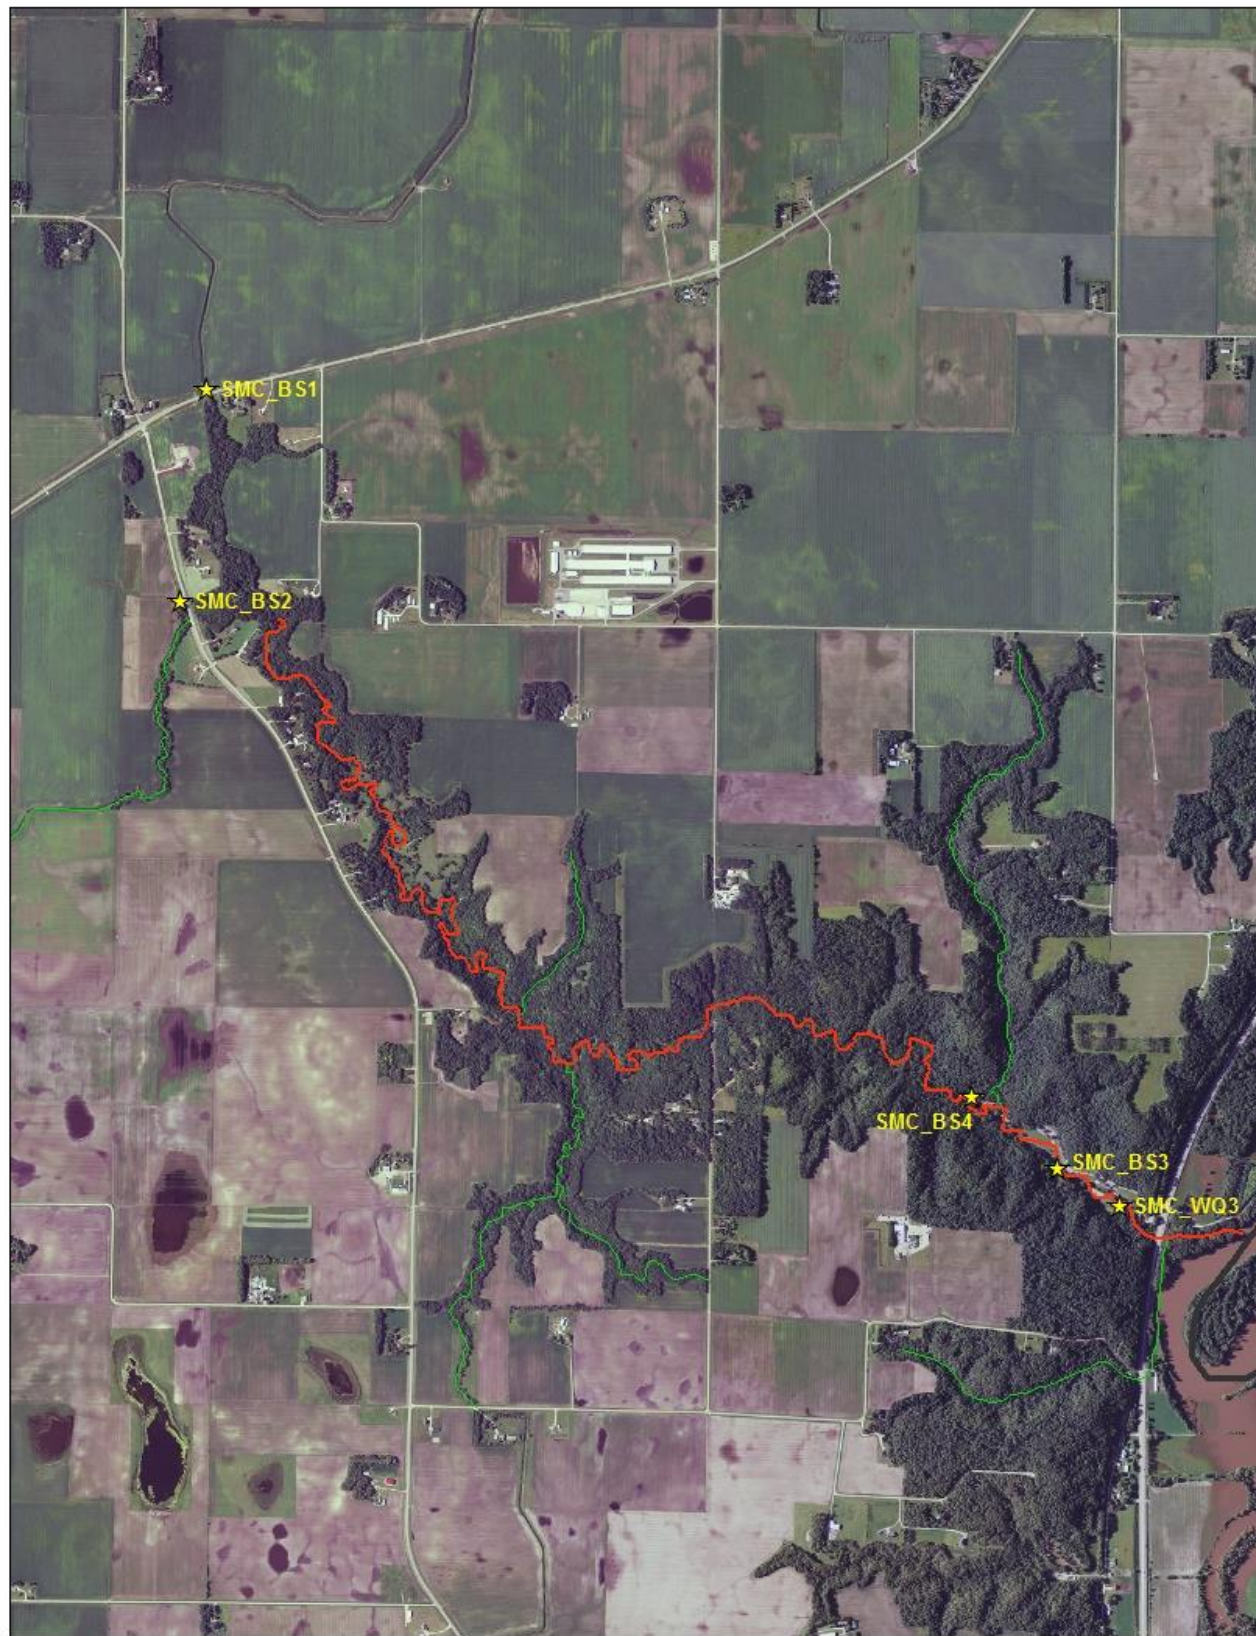
**Figure 1.** Sampling stations for the 2016 Seven Mile Creek special assessment.

**13. Reason for Survey:** To assess the fish community in conjunction with restoration measures being implemented as part of the Seven Mile Creek Watershed Program. Four standardized stations (SMB\_BS1 - SMB\_BS4) were sampled (Fig. 1). A Seven Mile Creek Watershed Program Monitoring Plan was written in December, 2011 and much of this report follows those protocols.
